FINAL REPORT

**Periodic Studies for 4-Lane,
Rewa- MP/UP Border
(Hanumana) Section from km
229/800 to km 140/600
(Length 89.3 km) of NH-7
(new NH-135 & NH-30) in the
state of Madhya Pradesh on
BOT Basis- VEPL**

**SAMARTH INFRAENGG Technocrats
Private Limited**

AUGUST 2025

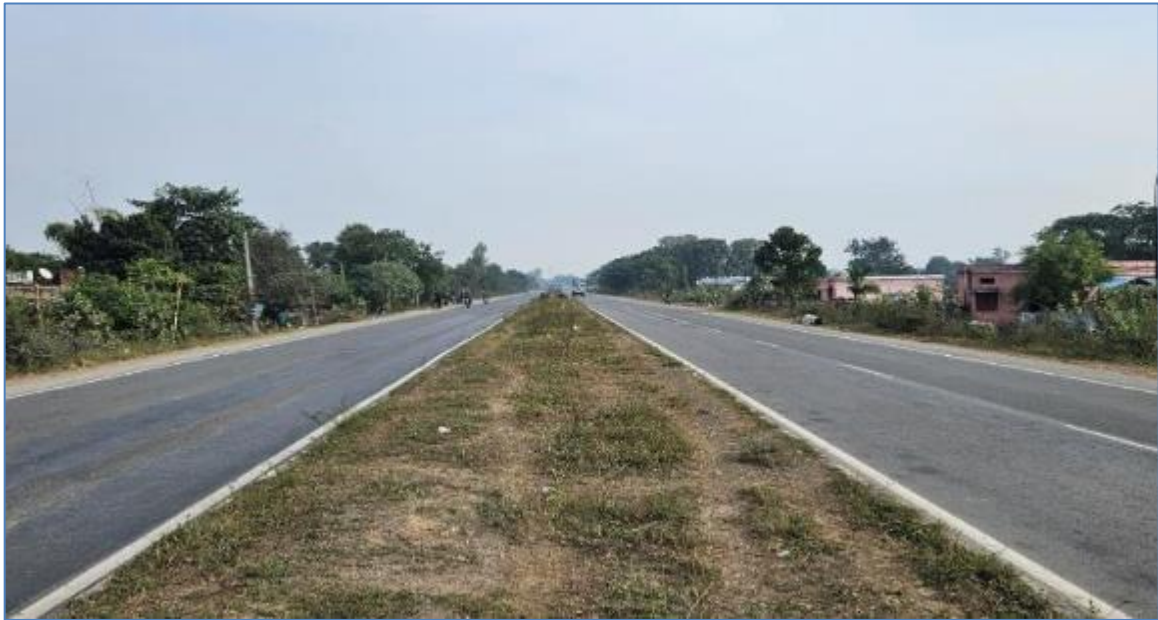
A View of Project Corridor with 4.5m wide Median @ Km 214.200

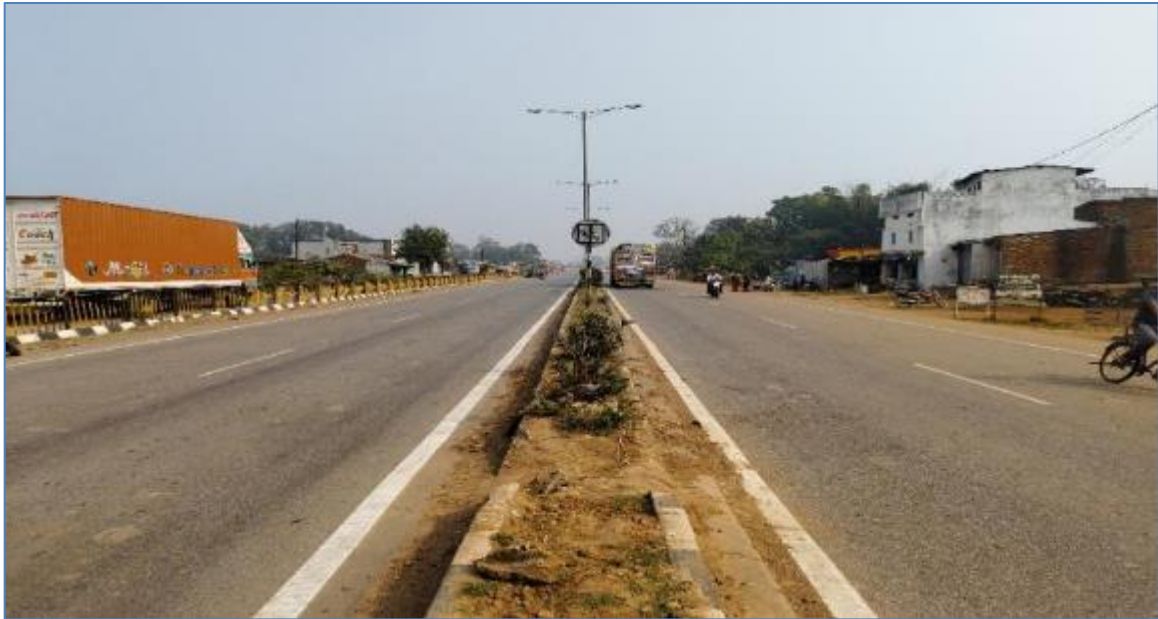
A view of the Project Corridor with 9.5m wide carriageway on both sides of 1m wide Median at Km 158.000

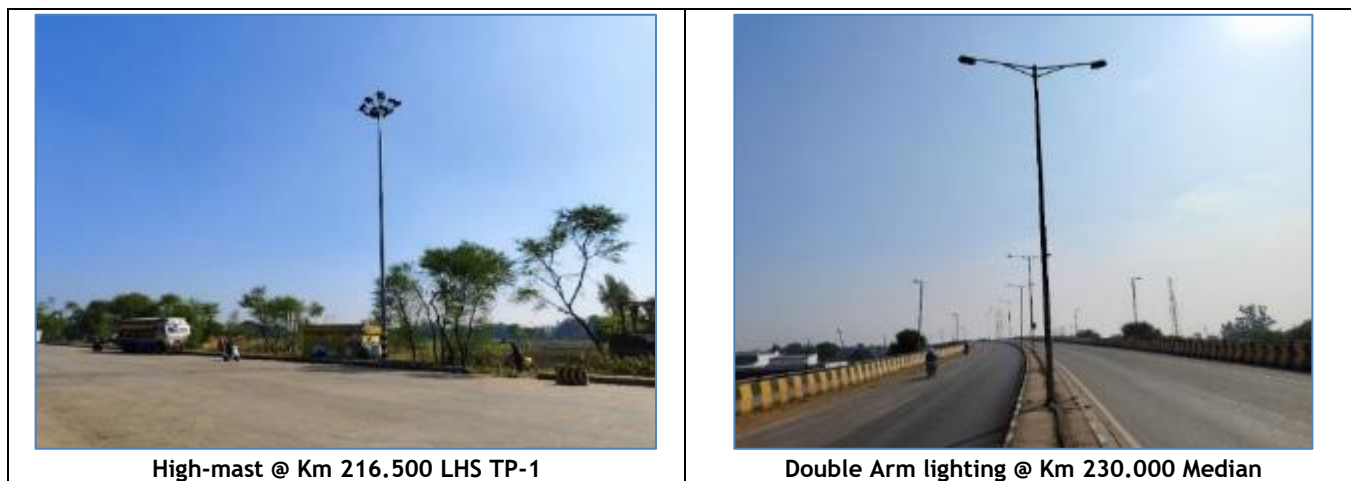
Double Arm Lighting @ Km 182.600 Median

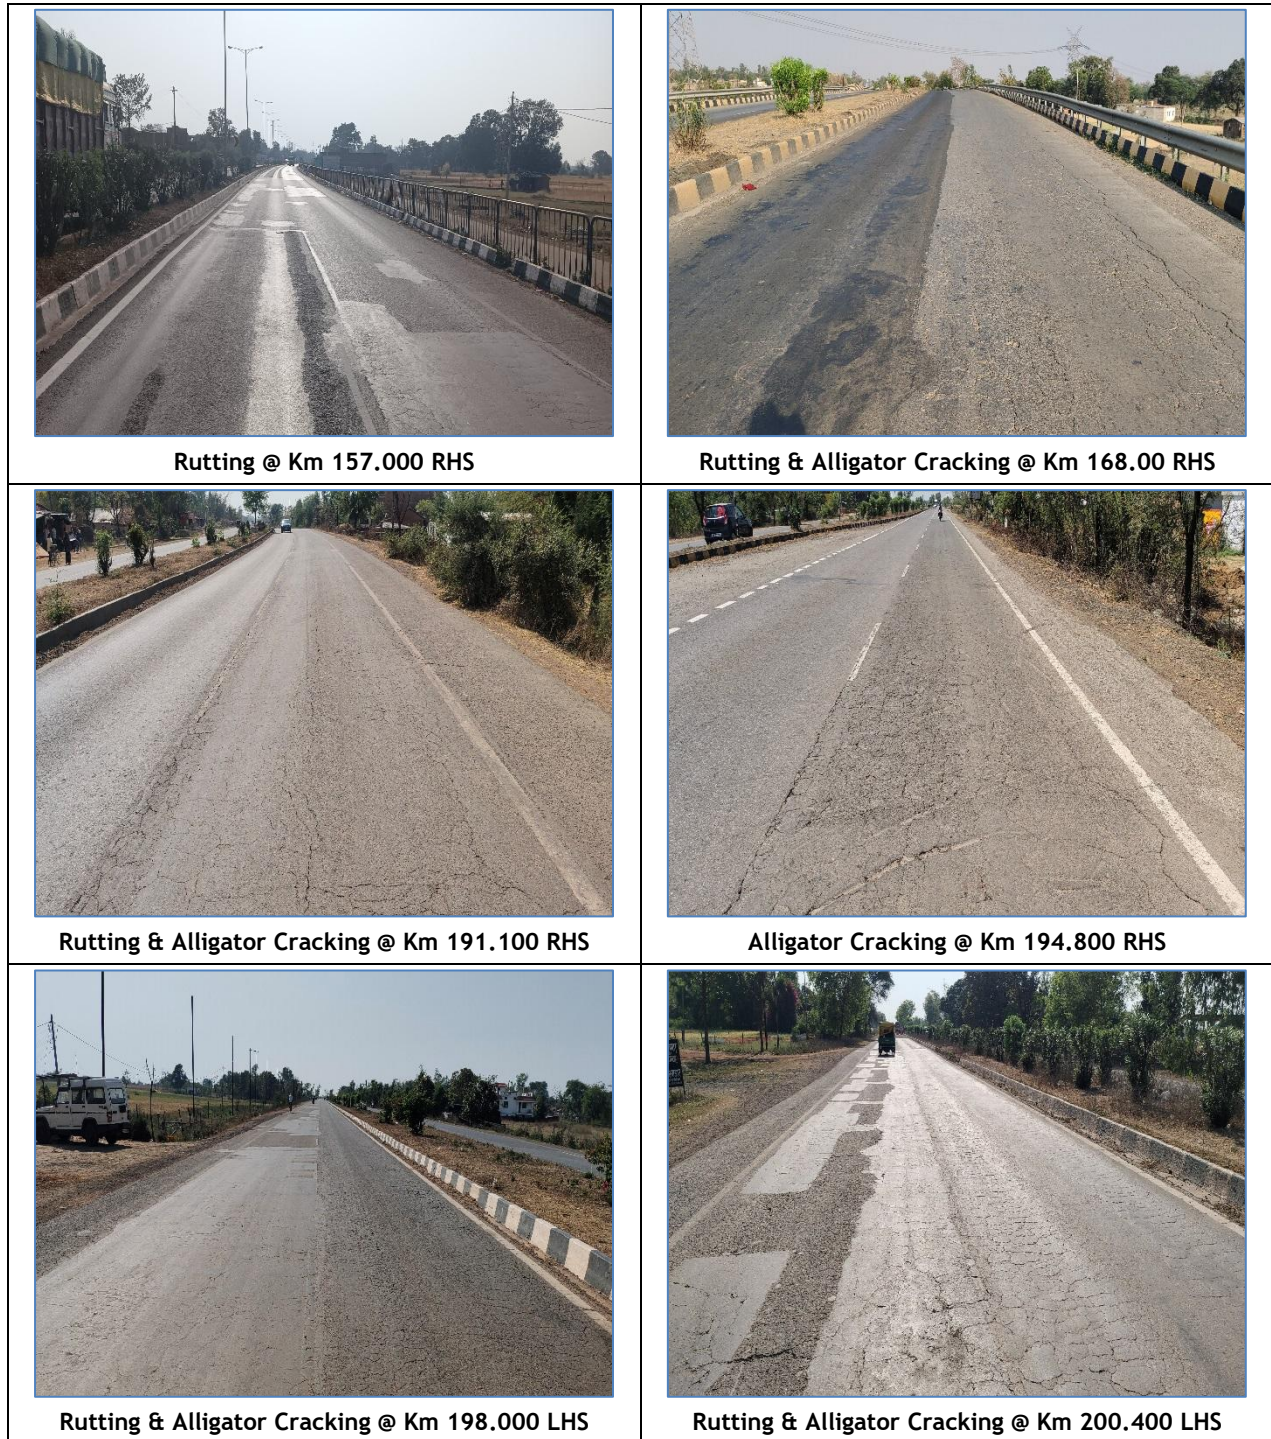
Inner-lane rutting associated with cracking is a common phenomenon observed in full length of the corridor in either carriageway. Even outer-lane carriageway also has hungry surface cracks associated with raveling, patching and rutting, but it is less when compared with inner-lane. It seems only maintenance works are ongoing by attending surface defects in the form of mill & overlay, MCS works and fog-seal to maintain the riding surface, either in inner-lane or outer-lane. No full-width overlay done in the project road thus far. Presently, pavement condition is average to poor.

Rutting & Alligator Cracking @ Km 202.000 LHS

Rutting & Alligator Cracking @ Km 210.000 RHS

Rutting & Alligator Cracking @ Km 221.500 LHS

Poor Condition @ Km 222.500 RHS-SR

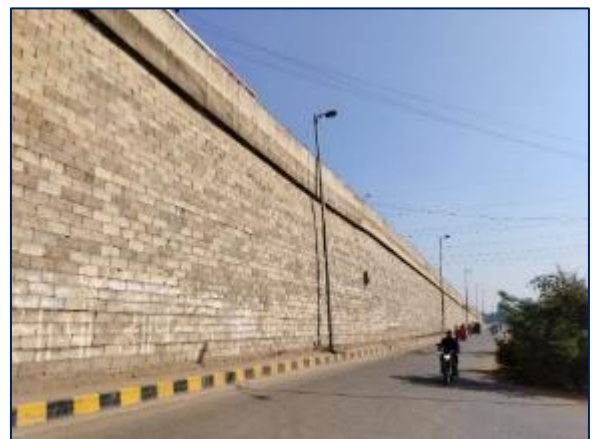
- Expansion joints were buried with debris and channel buried with bitumen.
- Drainage spouts clogged at some locations.
- Minor Cracks observed on RE blocks at some locations.

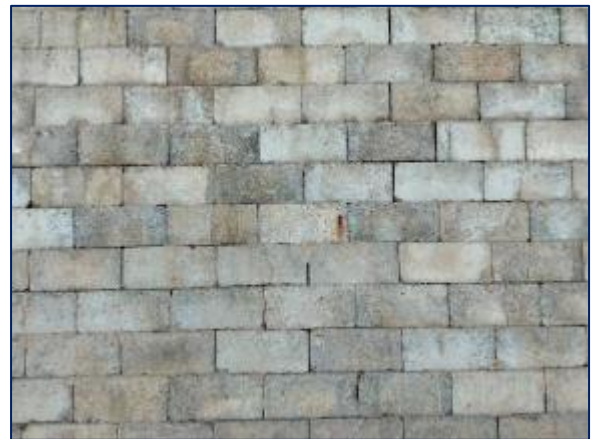
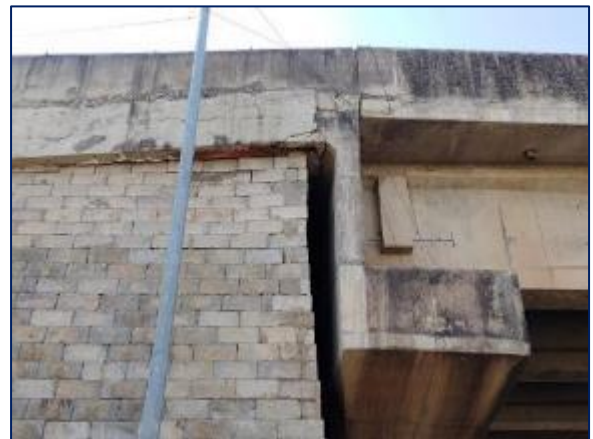
Chainage: 229+825

- Rubber Sealant damaged (minor) in Exp.Joint on both abutments. (2No)
- Minor Cracks observed on RE blocks at some locations.
- Friction slab crash barrier damaged on A-2 shoulder side dirt wall.

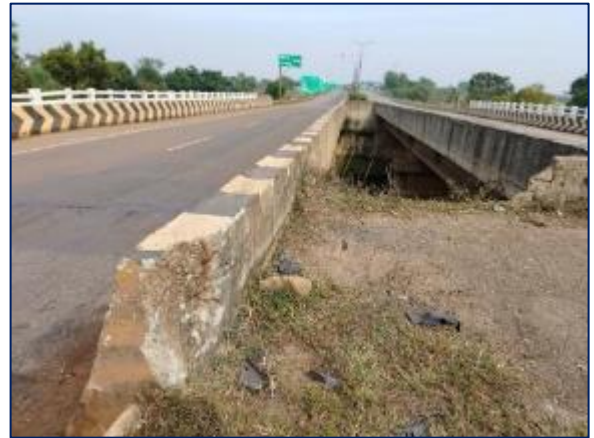
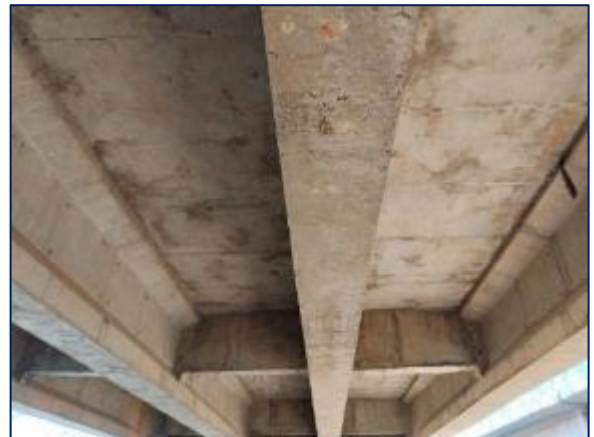
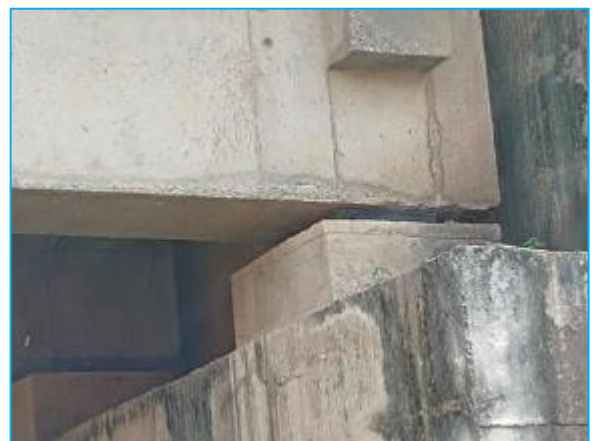
Chainage: 148+553

- Rubber Sealant damaged in all Expansion joints. (3 Nos)
- Honeycomb and steel exposed on Cantilever portion of deck slab.
- Cracks observed on soffit of deck slab in both spans & Abutment 1.
- Median crash barrier damaged on A2 side.

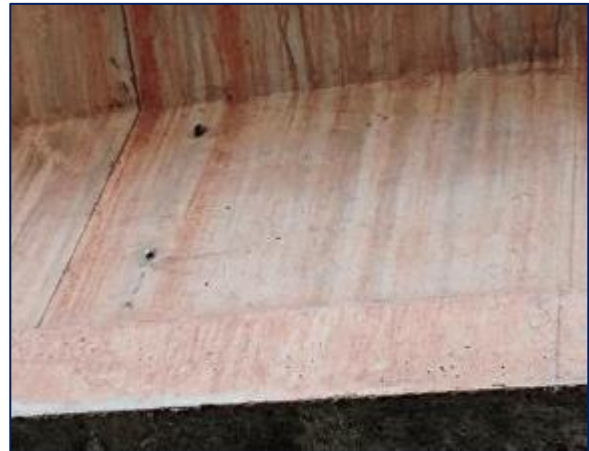
Chainage: 150+694

- Rubber Sealant damaged in Exp.Joints on both abutments. (2 Nos)
- Drainage spouts were clogged with debris.
- Silt and Debris observed on Abutment caps.
- Cracks observed on girders at some locations.

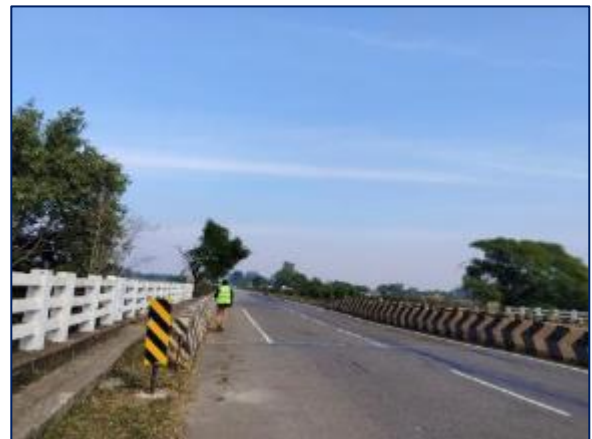
Chainage: 150+694

- Rubber Sealant damaged in Exp.Joints on both abutments. (2 Nos)
- Drainage spouts were clogged with debris.
- Silt and Debris observed on Abutment caps.
- Cracks observed on both abutments.

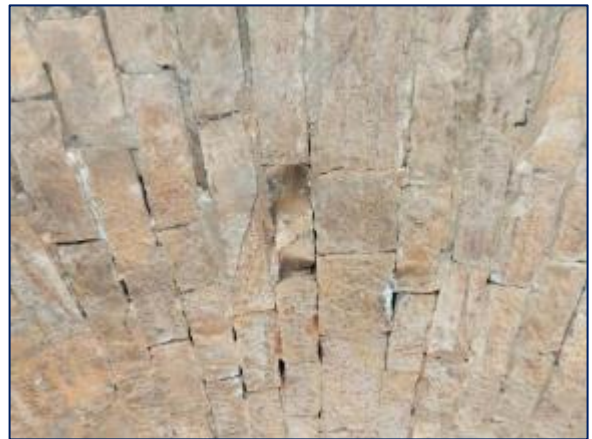
Chainage: 151+759

- Quadrant Slope protection partially damaged at A-1.
- Gaps observed between stones at some locations on Structure.
- Hand Railing missing about 1m on A2 side.

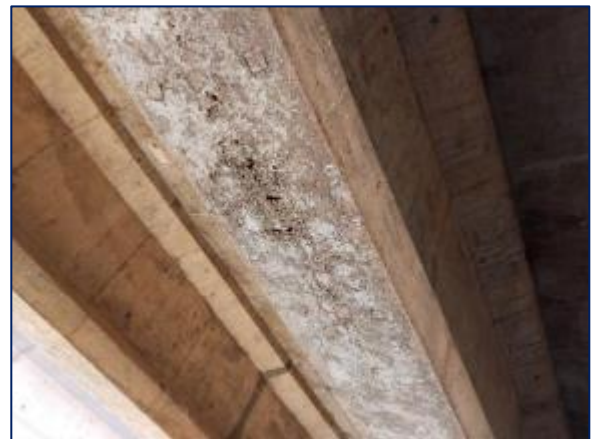
Chainage: 155+274

- Rubber Sealant damaged on both abutments. (2 Nos)
- Honeycomb observed on soffit of Girder G2 from median side.
- Cracks observed on girders at some locations and also soffit of deck slab between girders G-2, 3 & G-4 from shoulder side.

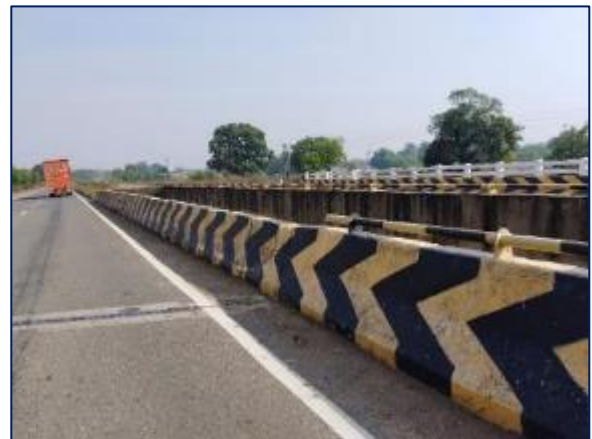
- Minor damage on Hand Railing at A-1 approach.
- Expansion joint are buried with BT Layers.
- Concrete portion damaged near Exp.Joint on A-1.
- MS Pipe railing missing on median Crash barrier about 28m in Sappn-1.

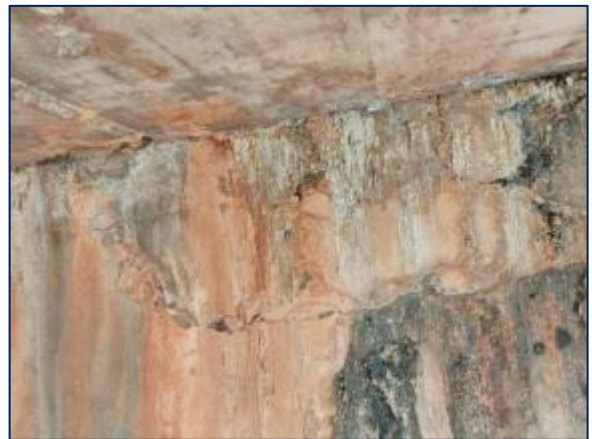
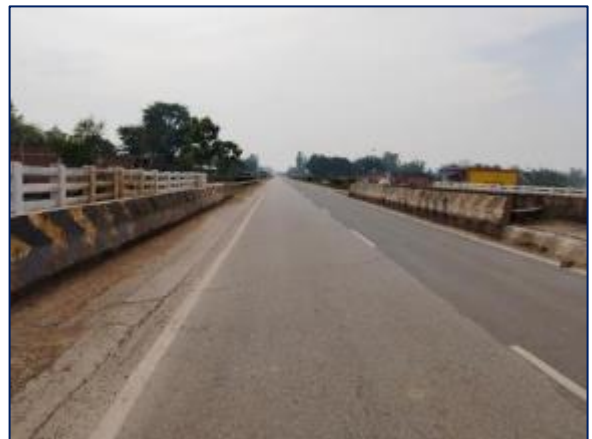
Chainage: 165+035

- Steel exposed on pier-1 at median side.
- Concrete surface damaged due to water leakage through expansion gap on Pier-1.
- Structure is in fair condition.

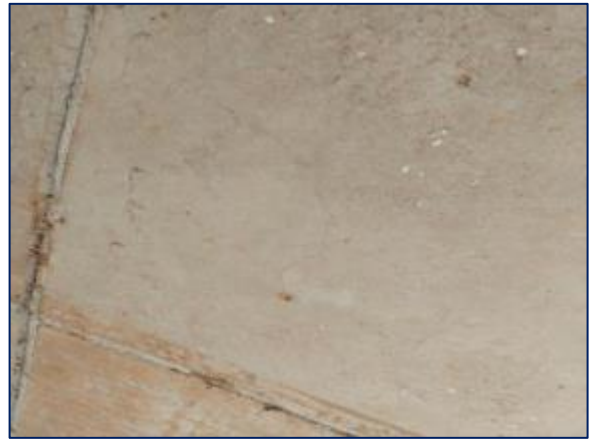
Chainage: 165+035

- Cracks observed on soffit of deck slab.

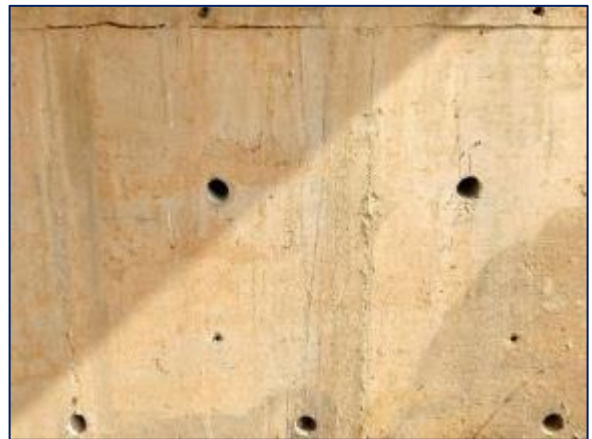
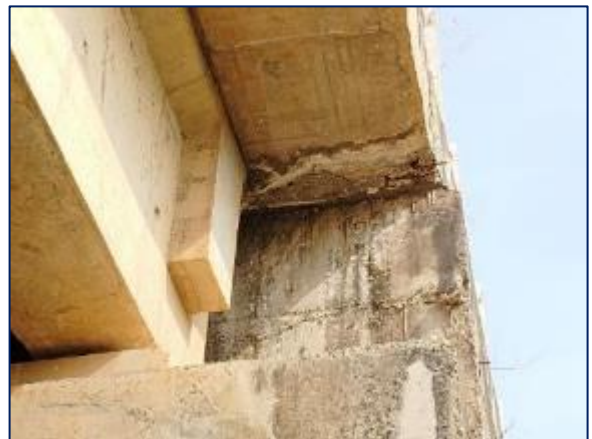
- Rubber Sealant damaged in expansion joint on pier P-1. (1 No)
- Cracks observed on both abutments.
- Honeycomb & Reinforcement exposed on soffit of deck near joint location.

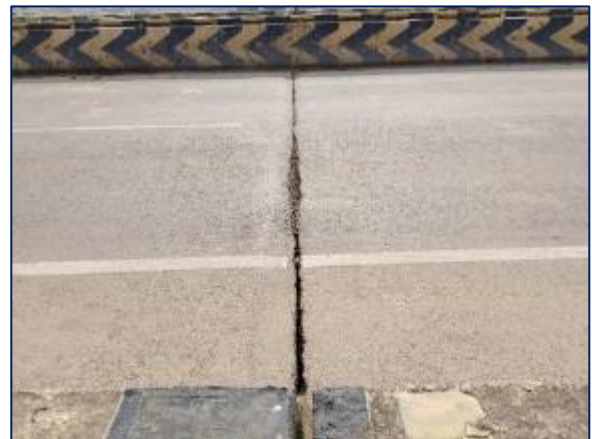
Chainage: 167+563

- Rubber Sealant damaged in expansion joint on pier P-1. (1 No)
- Cracks observed on both abutment and also on soffit of deck slab between girders G-1, 2, & 3 near Pier P-1.
- Honeycomb on deck soffit of cantilever portion from shoulder side near A-1.

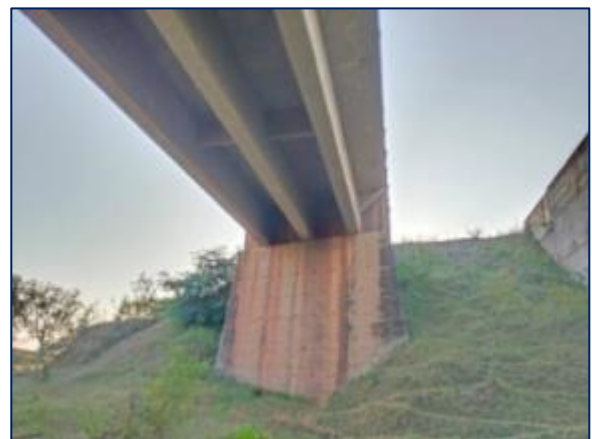
- Expansion joints buried under BT layers.
- Cracks observed on both abutments.
- Minor damage observed on Hand Railing.
- Drainage spouts clogged at some locations.

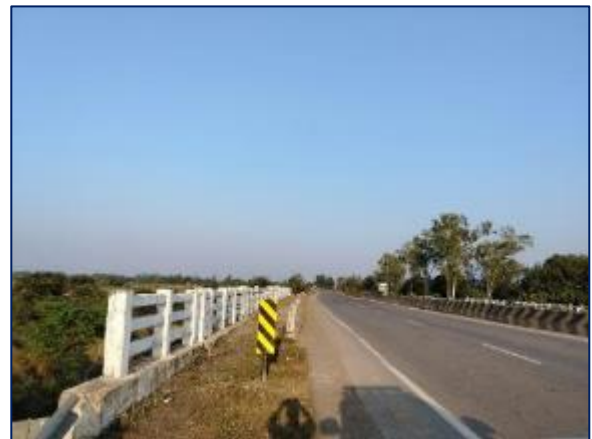
Chainage: 175+282

- Rubber Sealant damaged in expansion joint on pier P-1. (1 No)
- Cracks observed on abutment wall both abutments.
- Expansion joints were buried under BT Layers.
- Drainage spouts clogged at some locations.

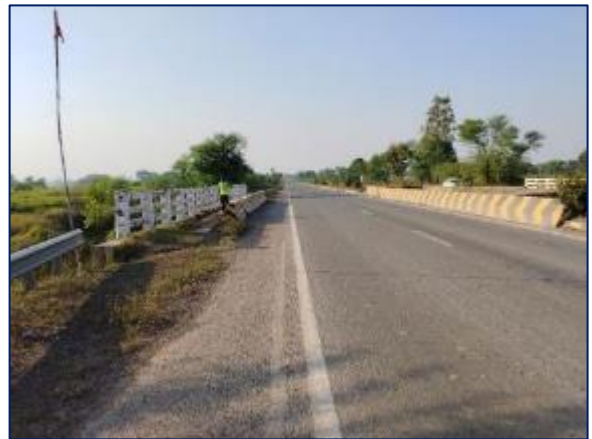
Chainage: 180+745

- Old Stone masonry Arch Bridge widened with RCC Structure.
- Vegetation growth observed on super structure.
- Gaps observed between stones at some locations on the Structure.

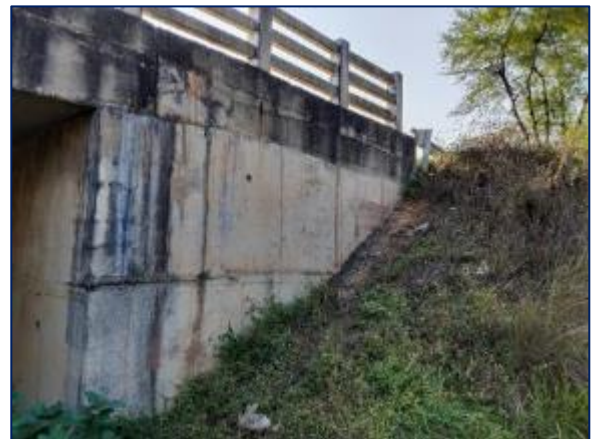
Chainage: 180+745

- Expansion gaps buried under BT Layer.
- Steel Exposed on bottom of median wall.
- Drainage spouts clogged at some locations.
- Structure is in fair condition.

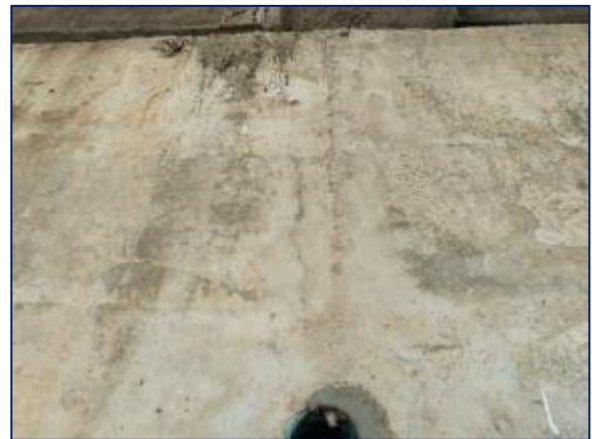
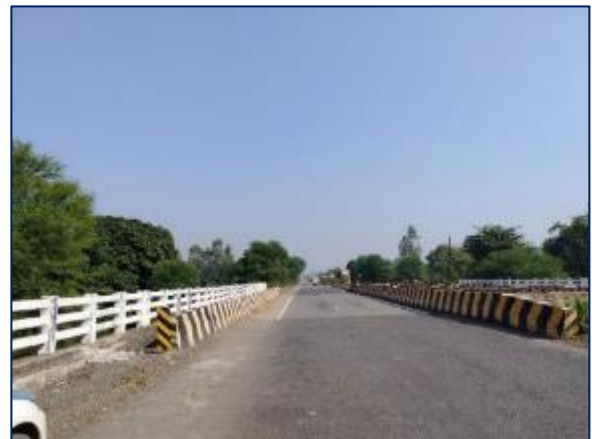
- Expansion joints were buried under bituminous layer on both abutments.
- Cracks observed on abutment wall A-2.
- Cracks observed on web portion of all girders in span-2 and Girder G-1 from median side in span-1.

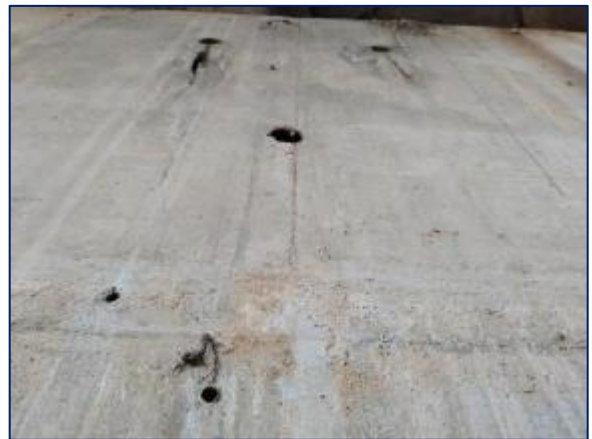
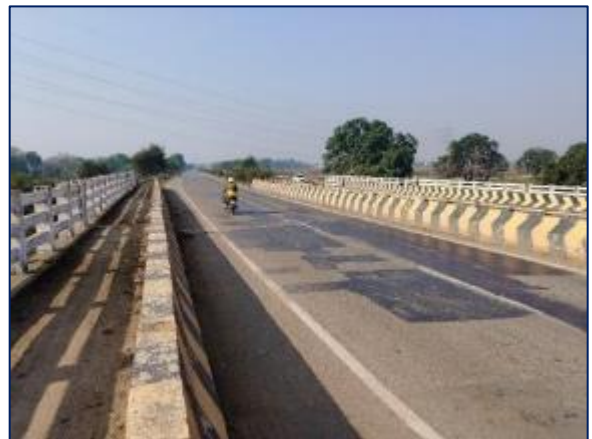
Chainage: 203+764

- MS Pipe railing damaged about 15m on median crash barrier.
- Cracks observed on both abutments.
- Expansion joints were buried under bituminous layer on both abutments.

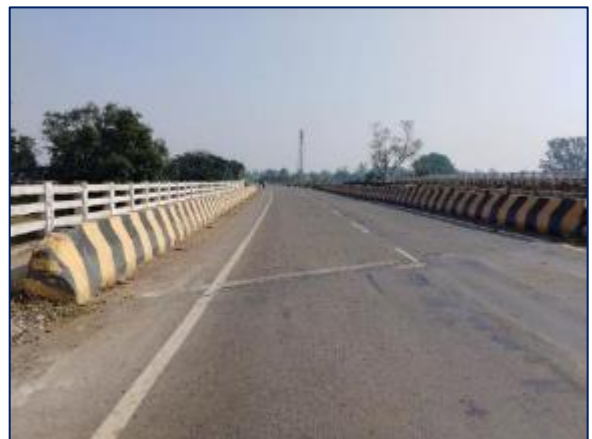
Chainage: 203+764

- Expansion joints are buried with debris.
- MS Pipe railing damaged about 40m on median crash barrier.
- Cracks observed on both abutments.

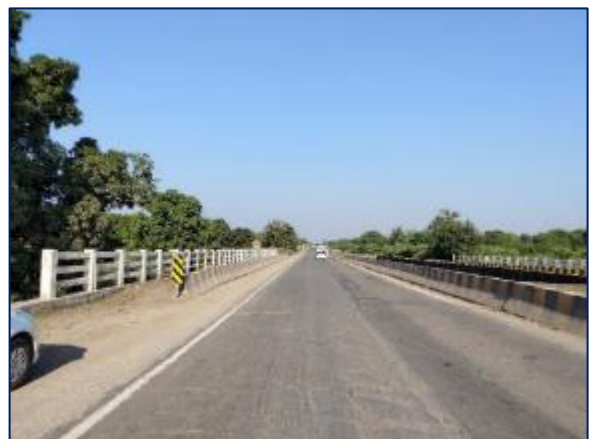
Chainage: 211+293

- Honeycombing observed on return wall at A-2.
- Drainage spouts clogged at some locations.
- Structure is in fair condition.

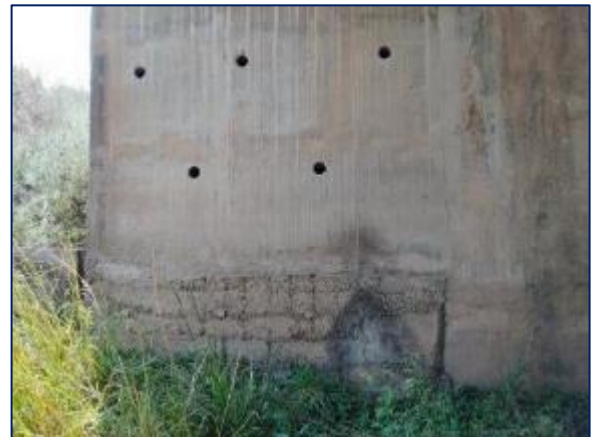
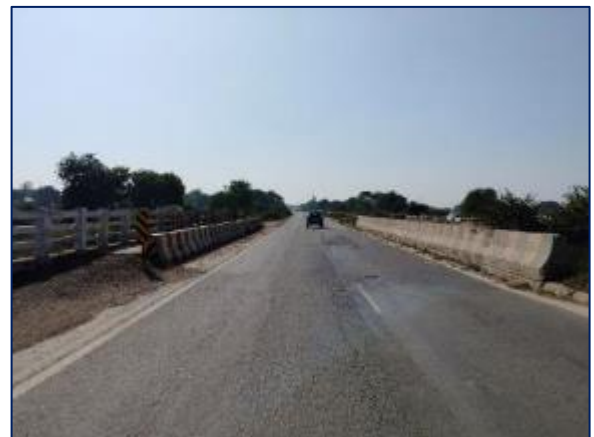
Chainage: 213+825

- Honeycombing & reinforcement exposed on bottom of A-2 wall at shoulder side.
- Drainage spouts clogged at some locations.

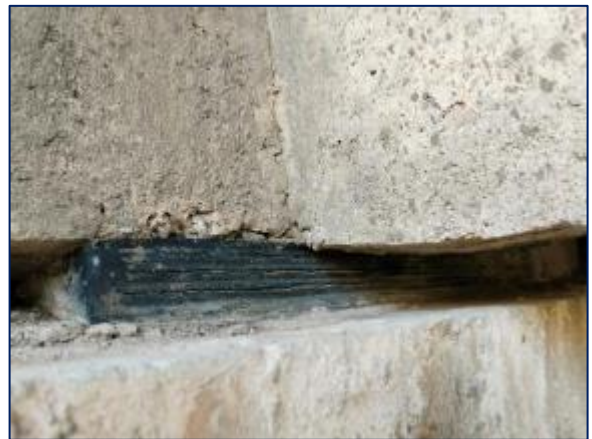
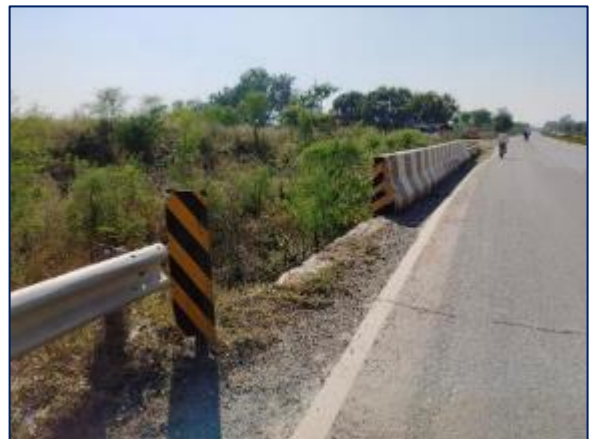
- Crash Barrier missing on A-1 Approach.
- Cracks observed on girders at some locations.
- Bearings distress(Cracks) observed on A-1 Bearing no. B-1 &3 from median side.

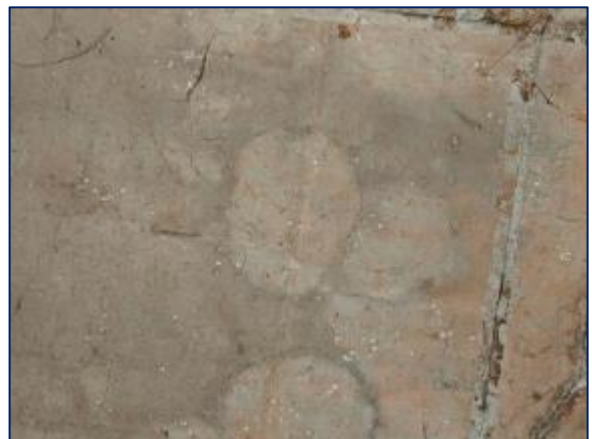
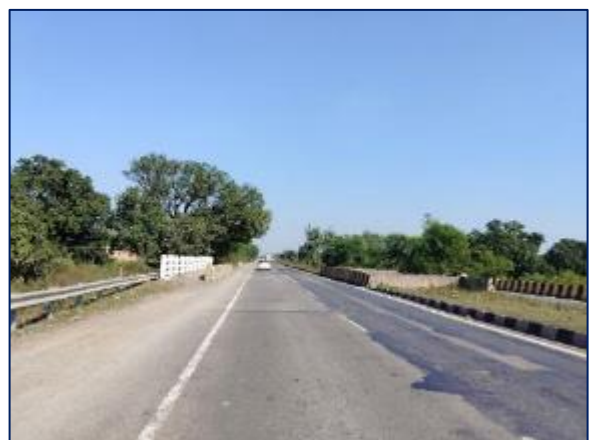
Chainage: 215+050

- Expansion joints were partially buried with debris.
- Cracks observed on deck soffit between girders G1, G2 & G3 from median.

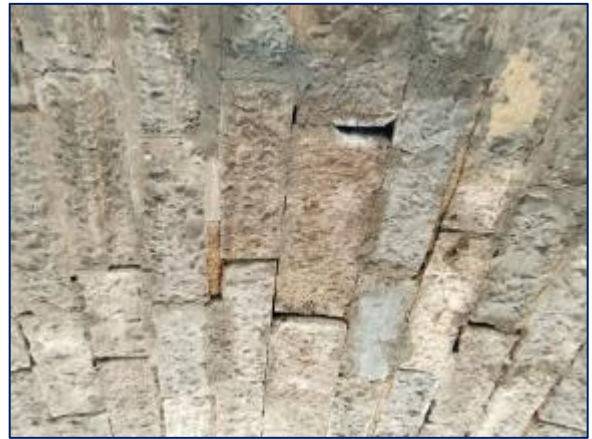
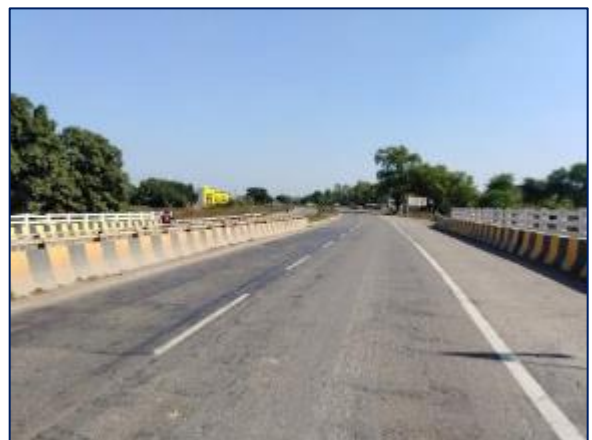
Chainage: 218+282

- Gaps observed between stones at some locations on Structure.

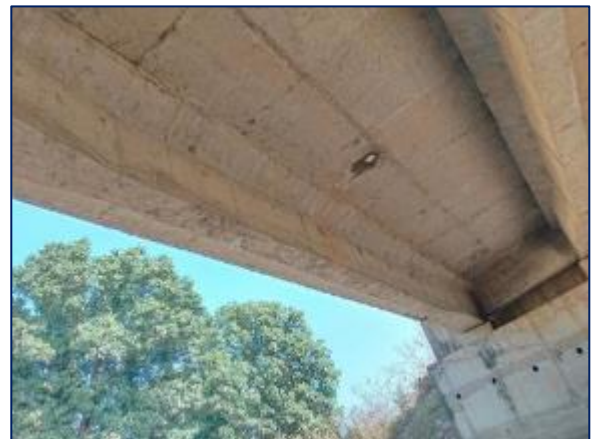
Chainage: 218+282

- Expansion joint damaged on A-2. (1 No)
- Rubber Sealant damaged in Expansion joint on P1 & A-1. (2 Nos)
- Honeycombing observed on soffit of girder G1 from median side in span-2.
- Drainage spouts clogged at some locations.

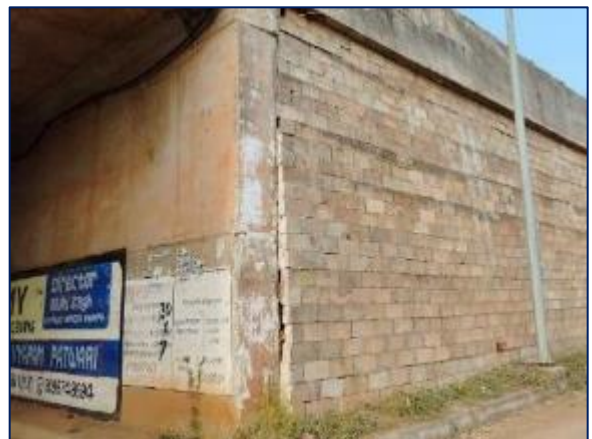
- Gap observed in between side wall and RE wall on A1 side.
- Gaps observed b/w RE Blocks on A-2 Approach RE Wall.

- The distresses like gaps/cracks/misaligned RE-blocks were observed at RE-wall portion of VUP @ km 152+840, VUP @ km 159+500 are attended by Concessionaire on temporary basis by filling with grout. However, cost provision shall be considered to rectification of these defects in MMR cycles.

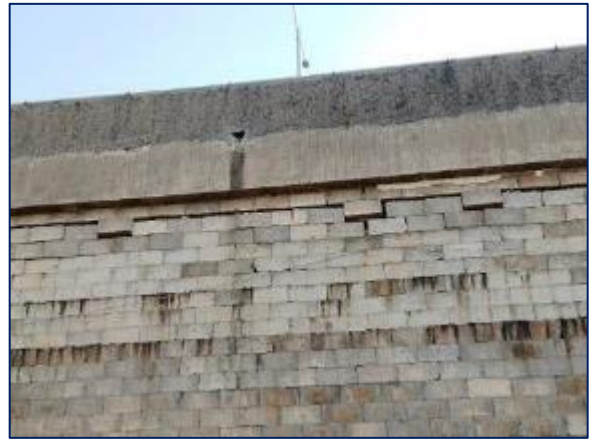
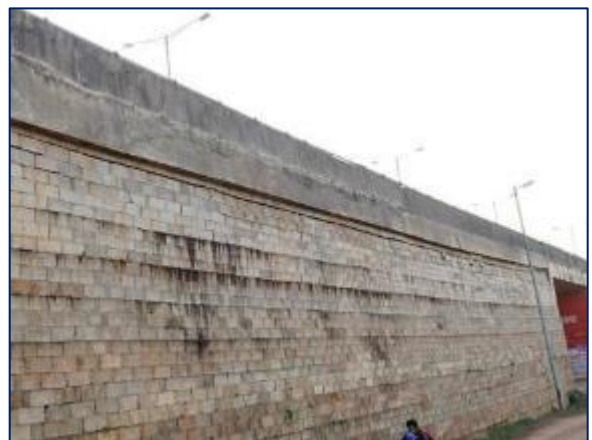
Chainage: 152+840

- Gap and Settlement observed on RE Wall (Blocks) at Abutment-1 approach.

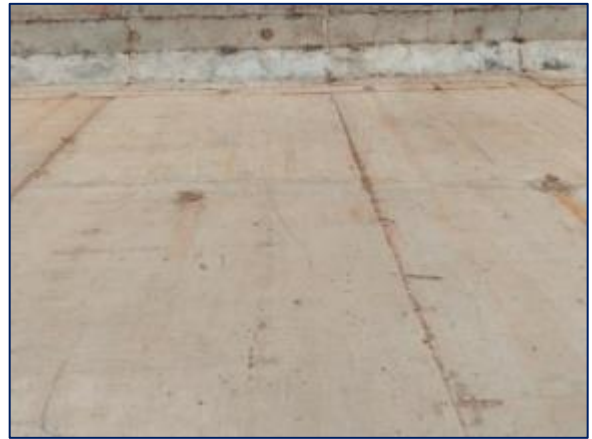
Chainage: 163+659

- Cracks observed on both side walls and soffit of deck slab.

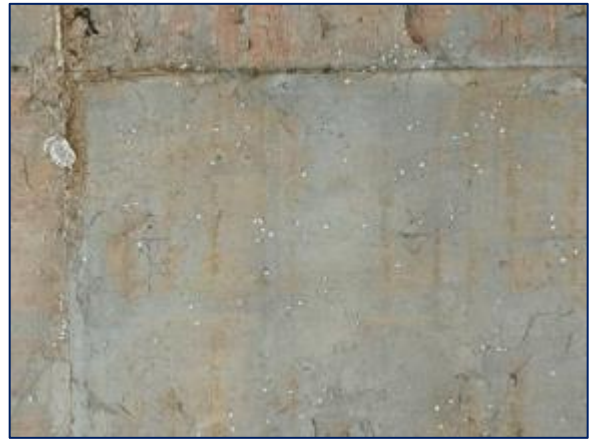
Chainage: 174+220

- Cracks observed on soffit of deck slab.

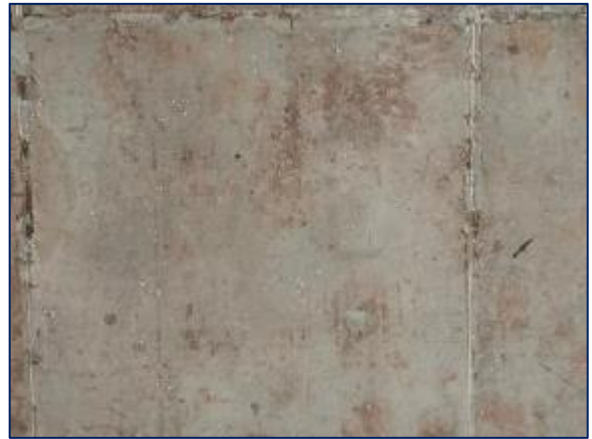
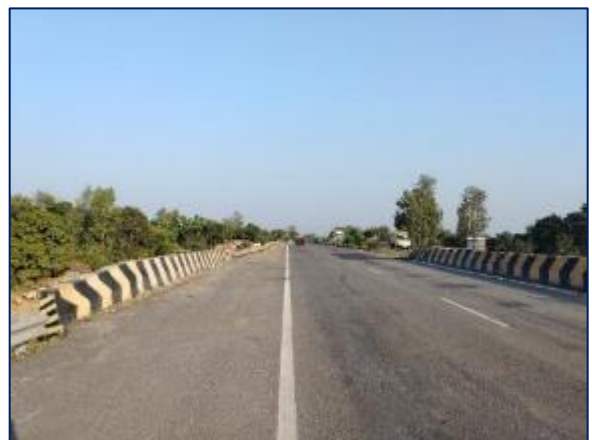
- Minor Cracks observed on soffit slab.

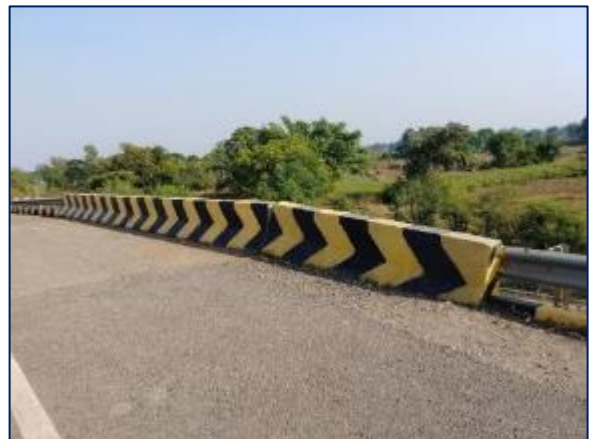
Chainage: 181+900

- Crash barrier settlement observed on A-1 approach.
- Cracks observed on soffit of deck slab.
- Median side wall damaged.
